San Jacinto River Waste Pits Superfund Site

USACE Support

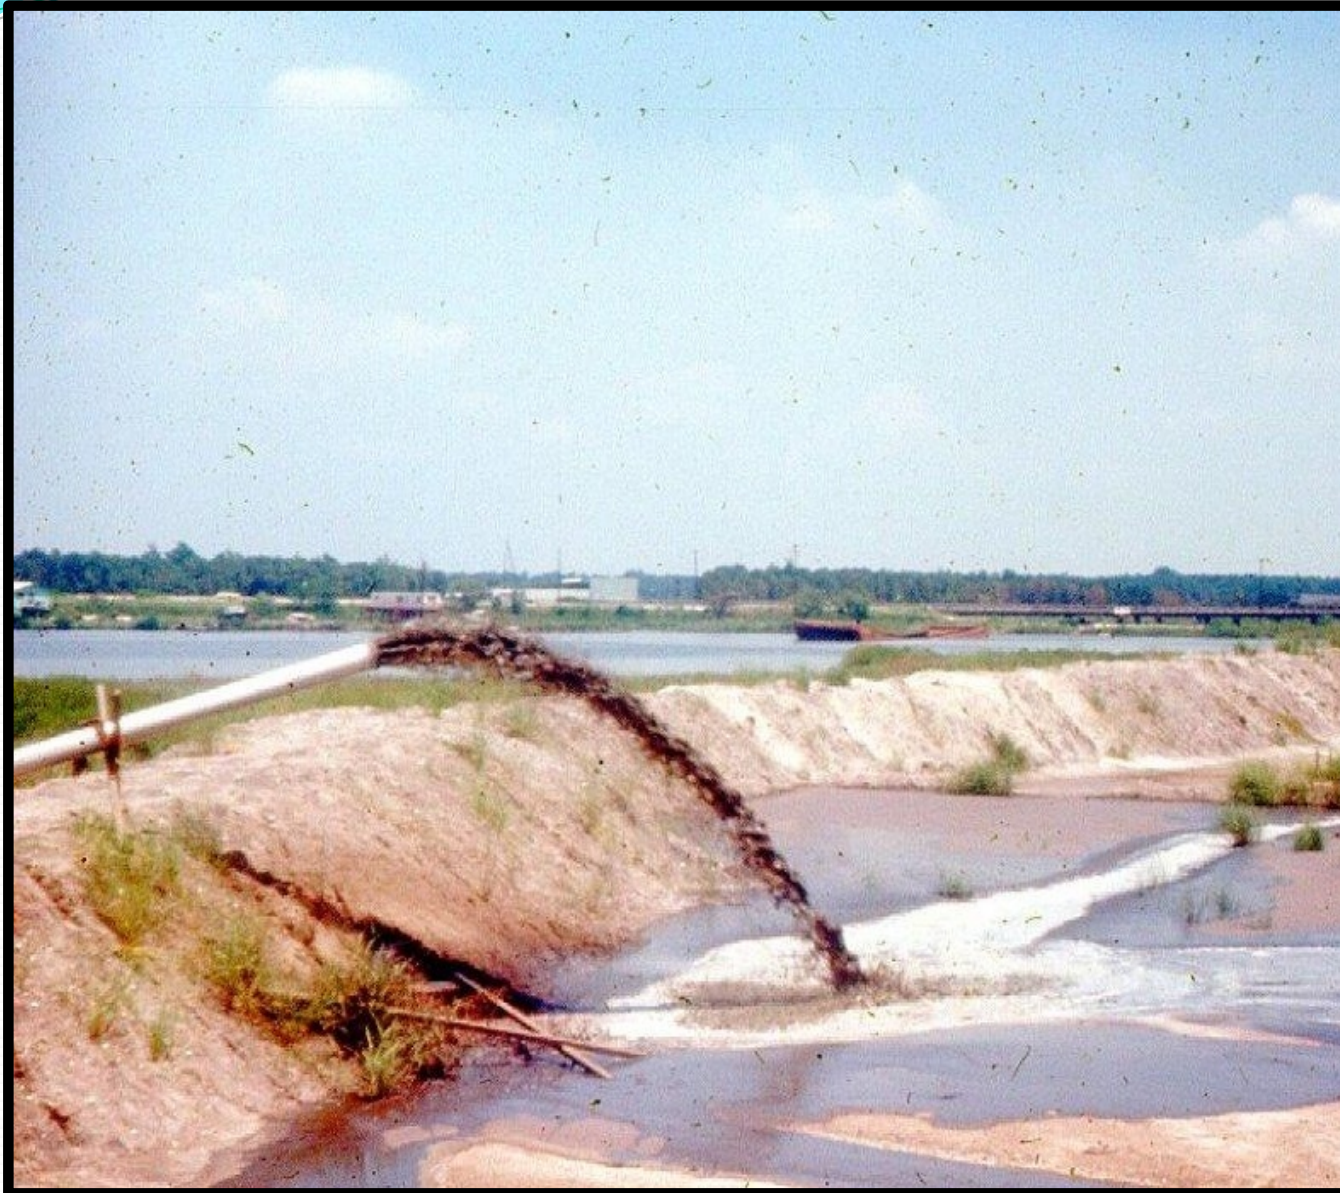
Oct 1964

San Jacinto River Waste Pits

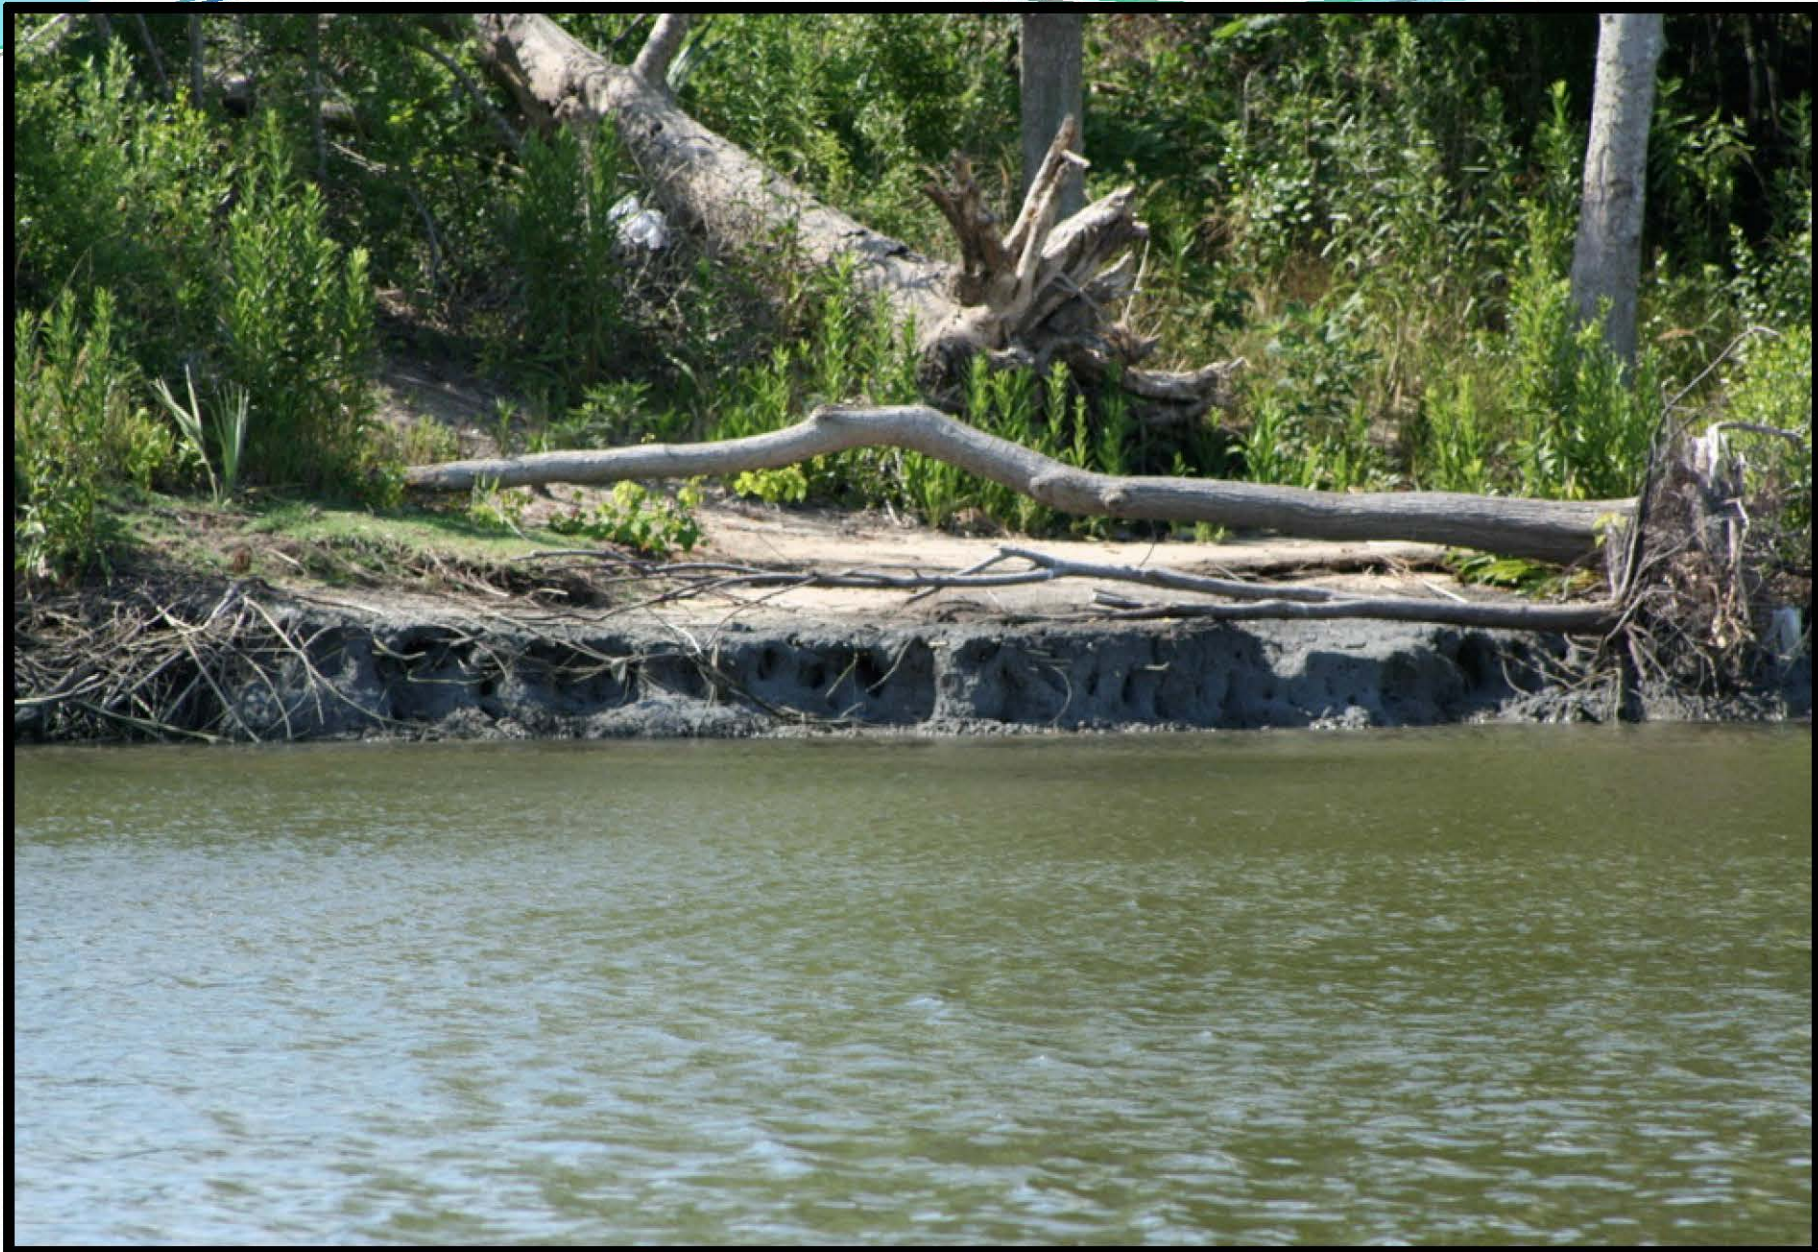
**South
Impoundment
1965**

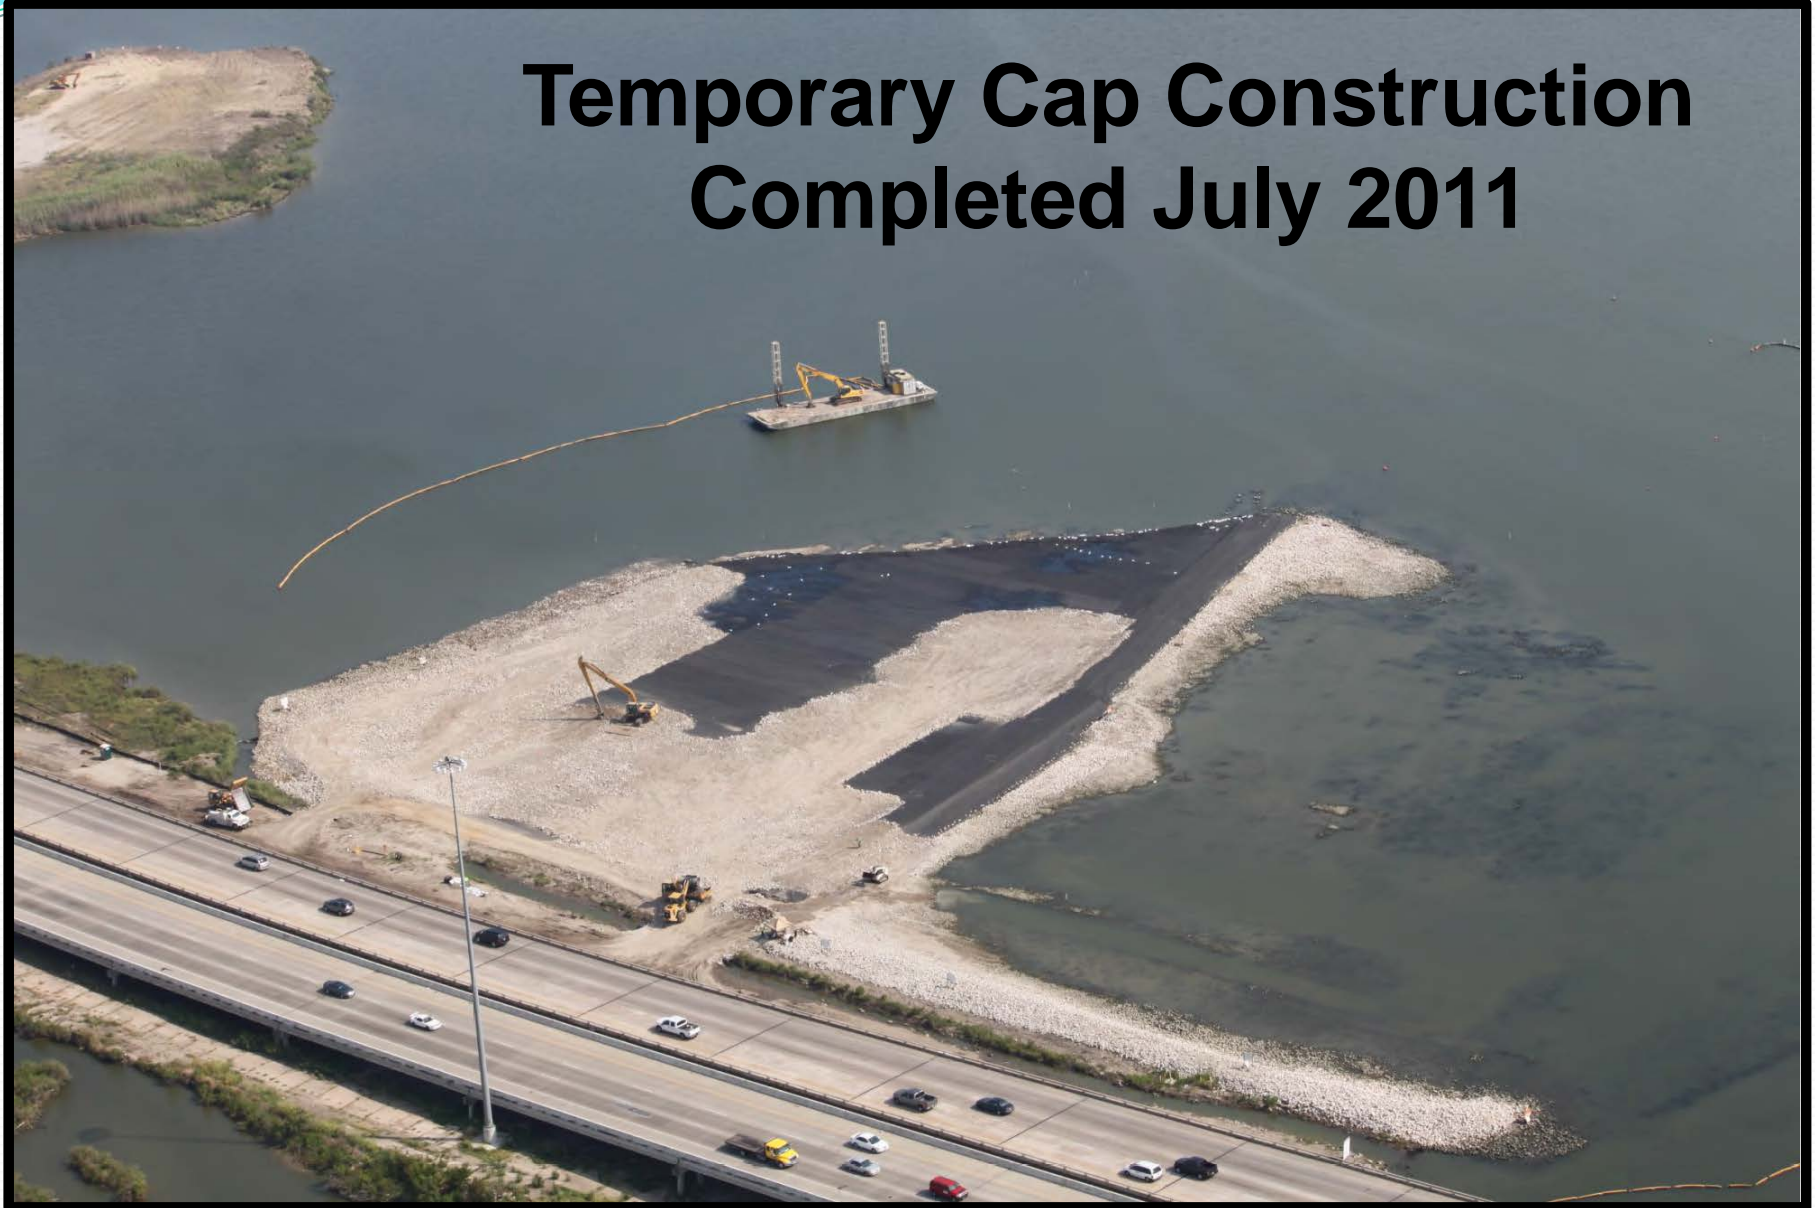
Temporary Cap Construction Completed July 2011

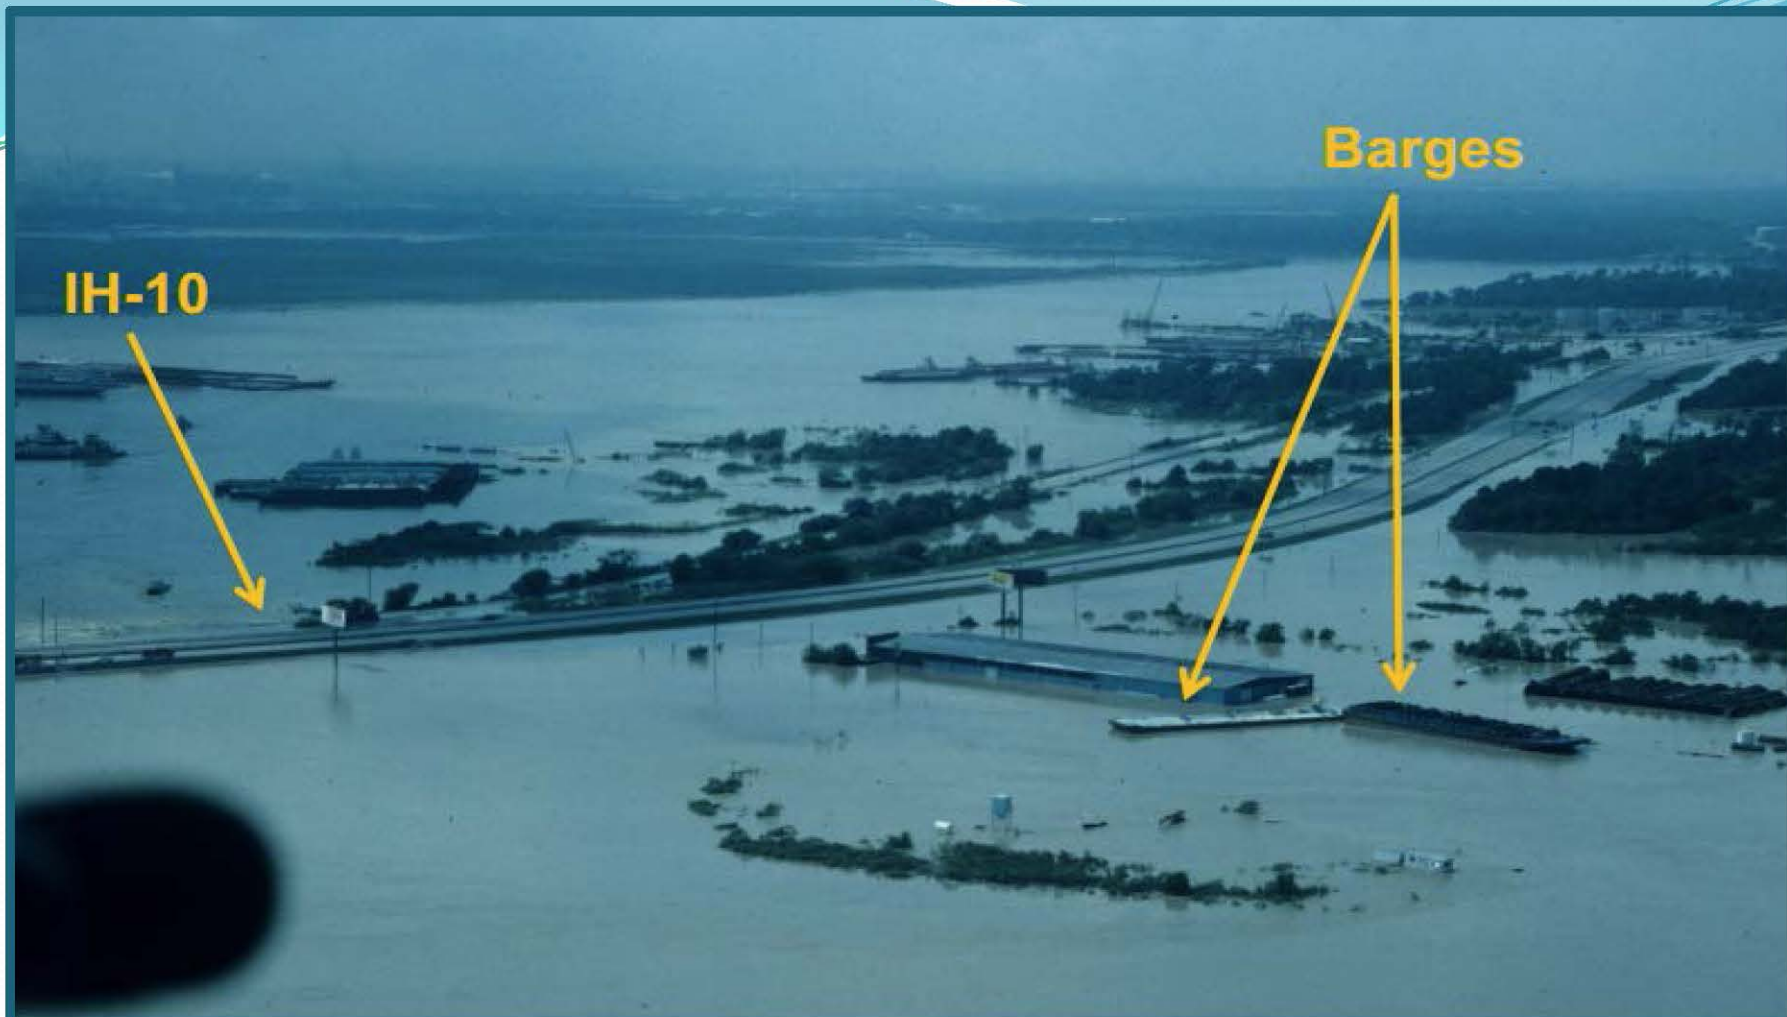
Lower San Jacinto River

San Jacinto River at I-10 (Photo: HCFCD)

- Upper Texas coast recorded 25 hurricanes, 7 of which were major (Category 3 to 5) storms.
- October 1994 storm greater than 100-year flood (1.6 times):
 - Major soil erosion – 8 pipelines ruptured & 29 undermined; 3000 homes destroyed.
 - 10 to 12-feet of bed scour south of the I-10.

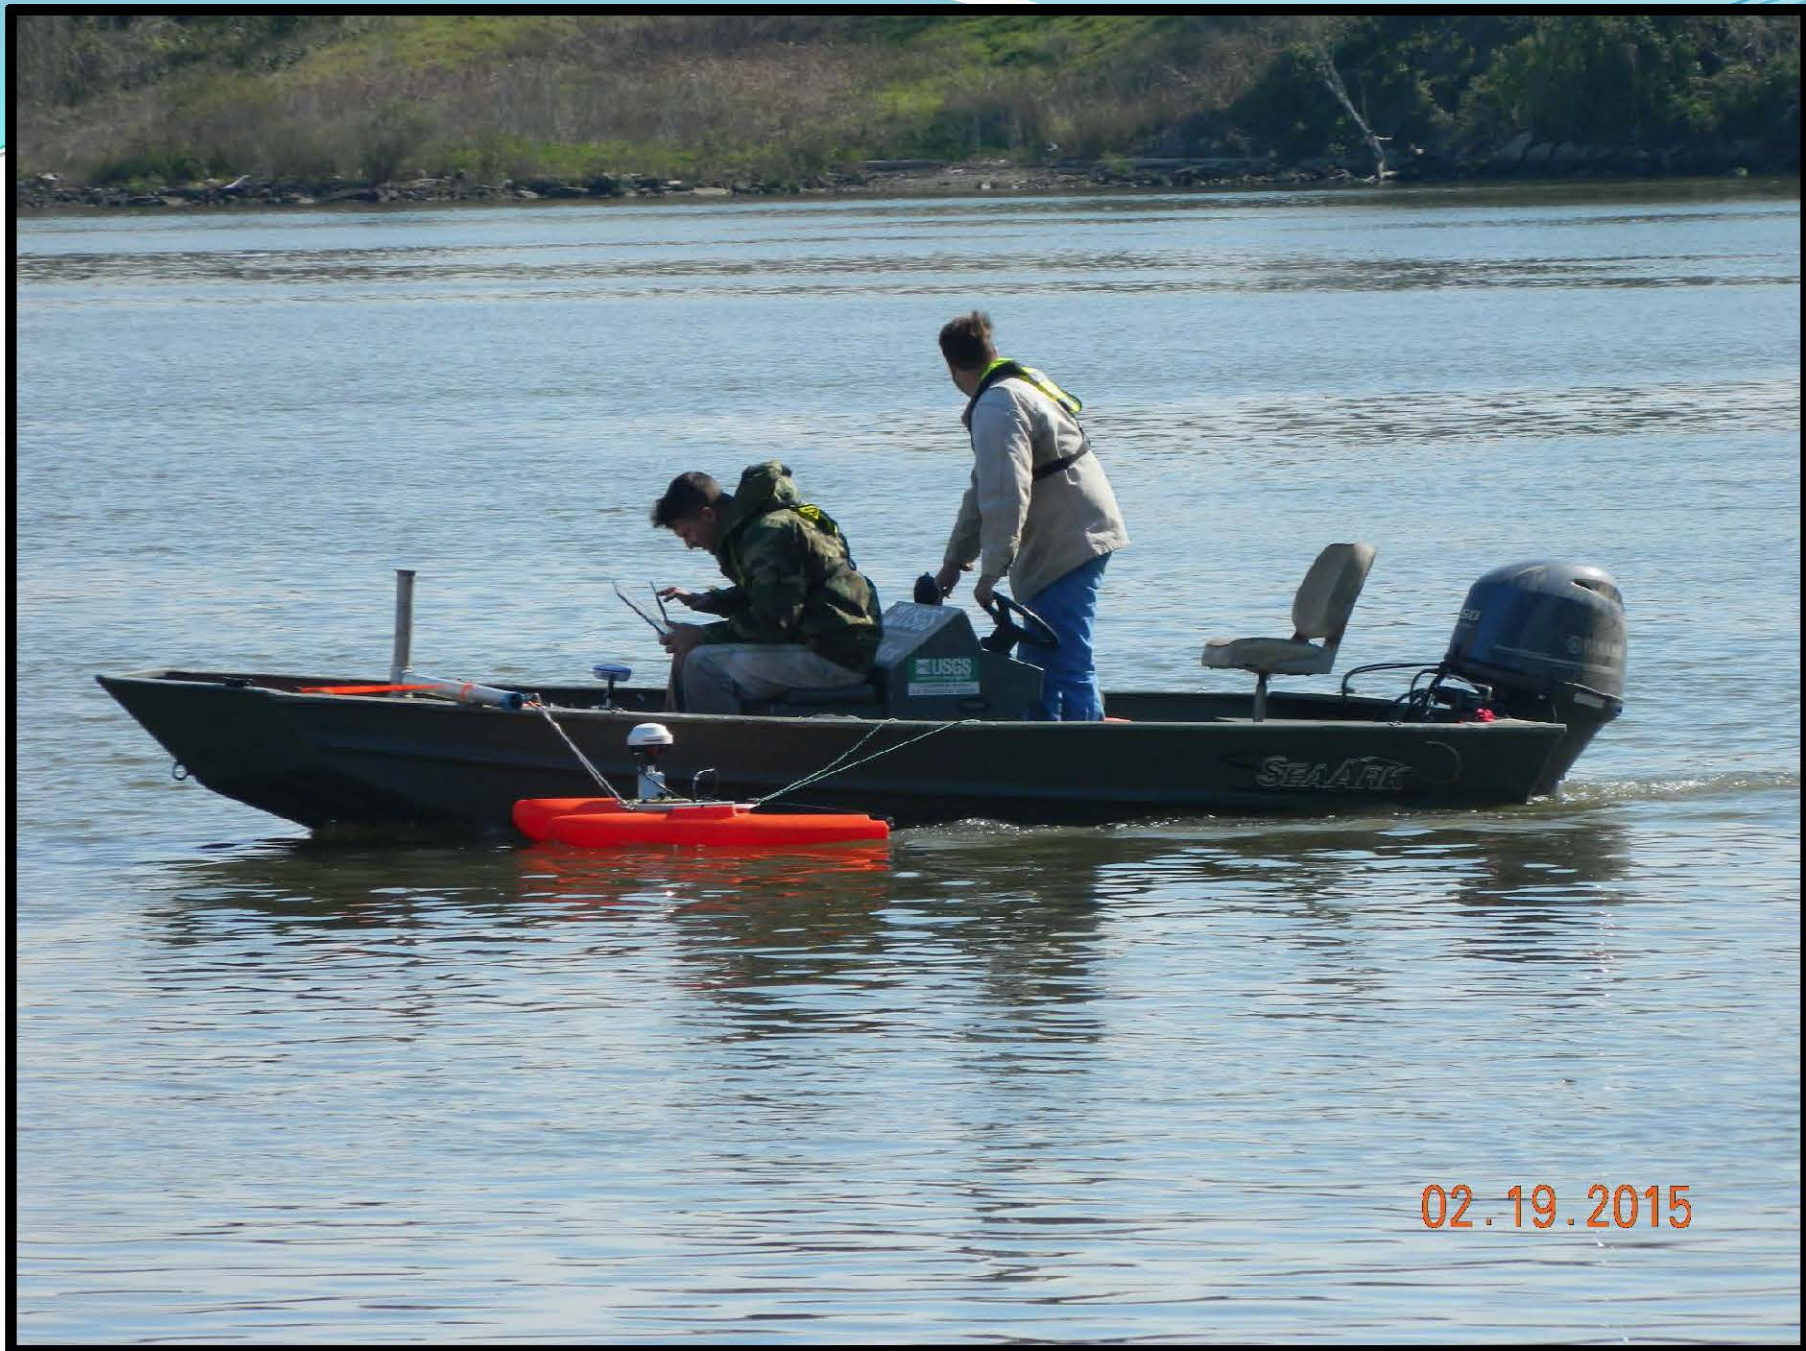
Lake Houston

SJR Waste
Pits

Houston Ship Channel

2.838 Kilometers

Morgan's Point

- Computer models – river flow & scour.
- Evaluation of remedial alternatives.
- Short & long term cap reliability? [storms, prop wash & barge strikes].
- Any migration through cap?
- Removal Best Management Practices.
